INDOOR AIR QUALITY ASSESSMENT

**Berkshire Community College
Melville Hall
1350 West Street
Pittsfield, MA**

Prepared by:
Massachusetts Department of Public Health
Bureau of Environmental Health
Indoor Air Quality Program
June 2017

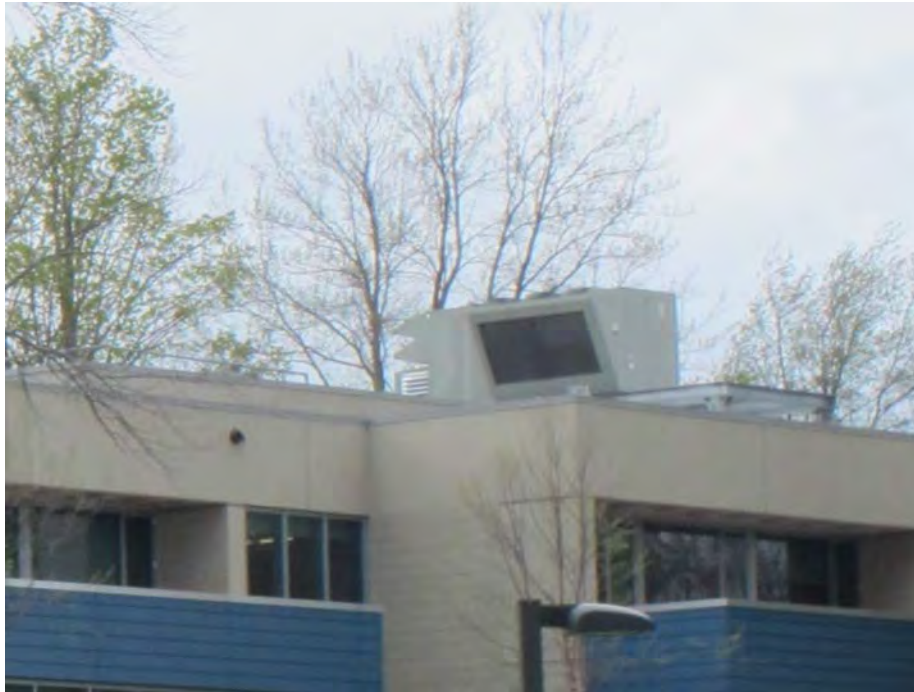
Picture 1

Fresh air ventilation is provided to MH by three large air handling units (AHU) which are located on the roof (Picture 1). The ventilation system uses a desiccant wheel which recovers heat/energy from the exhausted air stream and transfers this energy to the incoming fresh air. It was reported by BCC Facilities staff that the system does not direct bathroom or kitchen exhaust to the desiccant wheel and instead ejects these waste streams directly outside of the building as recommended by MDPH.

Air handling unit (AHU) on the roof of Melville Hall

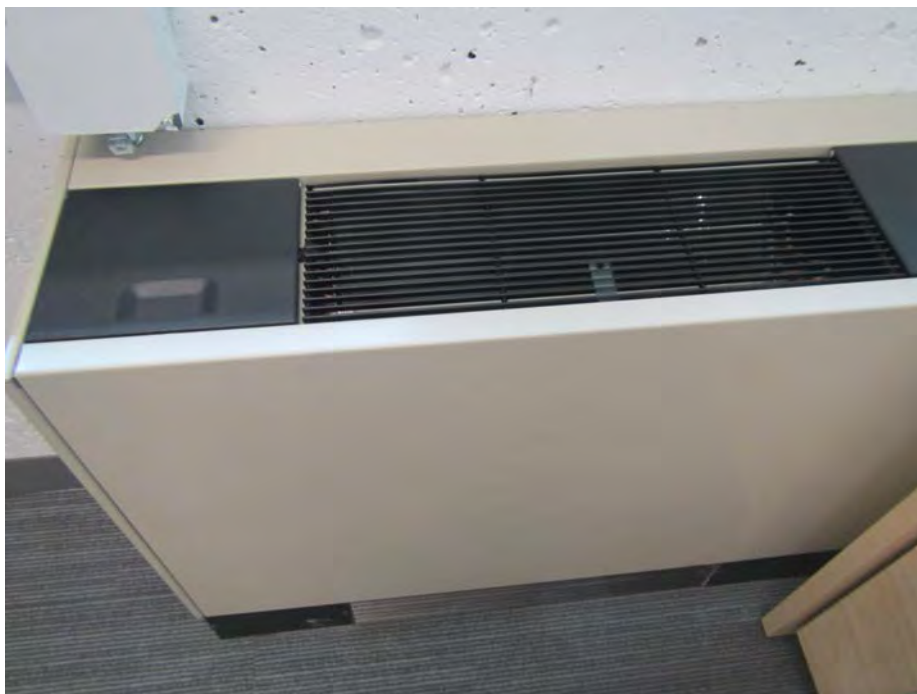
Picture 2

Space heating is supplemented by fan coil units (FCU) controlled by thermostats (Picture 2). These FCUs heat/cool the space on demand but fresh air ventilation supplied by the AHUs is on continuously as recommended by MDPH.

Thermostat-controlled fan coil unit (FCU)

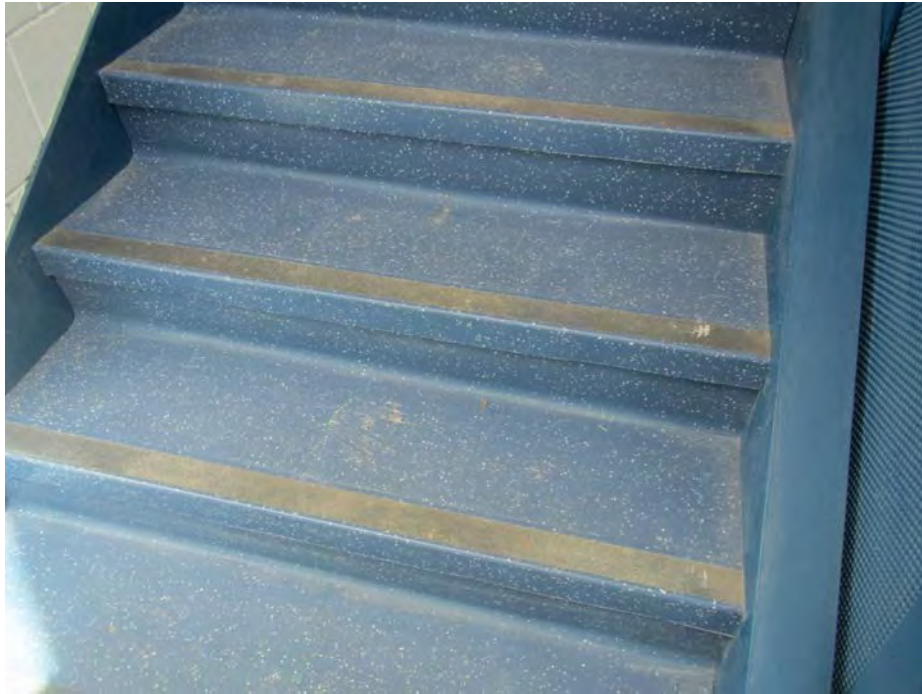
Picture 3

New vinyl flooring in stairwell area

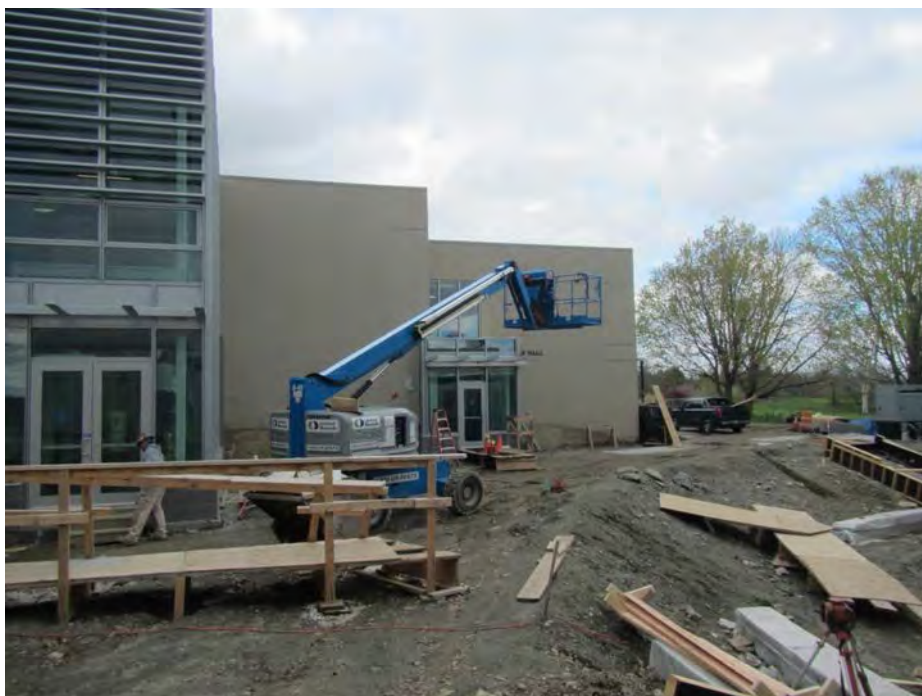
Picture 4

Construction activities were being performed outside of MH (Picture 4) at the time of this assessment. BEH staff noted one elevated particulate matter (PM 2.5) reading that was taken in an unoccupied hallway area immediately adjacent to the construction. It is likely that the idling of construction equipment in close proximity to the building may have caused this temporary increase in PM 2.5 in this isolated area. Efforts should be made to schedule particularly dusty/odorous construction activities during unoccupied hours, ensure that walls and other barriers between occupied areas and areas where construction are occurring are intact, and temporarily close the AHU nearest the construction if needed. Please consult [Appendix A](#), “Methods Used to Reduce/Prevent Exposure to Construction/Renovation Generated Pollutants in Occupied Buildings” for more information.

Construction activities outside of Melville Hall

1. Continue to follow MDPH guidelines ([Appendix A](#)) concerning renovations while building is occupied. This may include installing adhesive-style walk off mats in entrances leading to construction areas to avoid tracking dust/debris from construction site and scheduling dusty/odorous activities during unoccupied hours or temporarily closing AHU nearest construction.

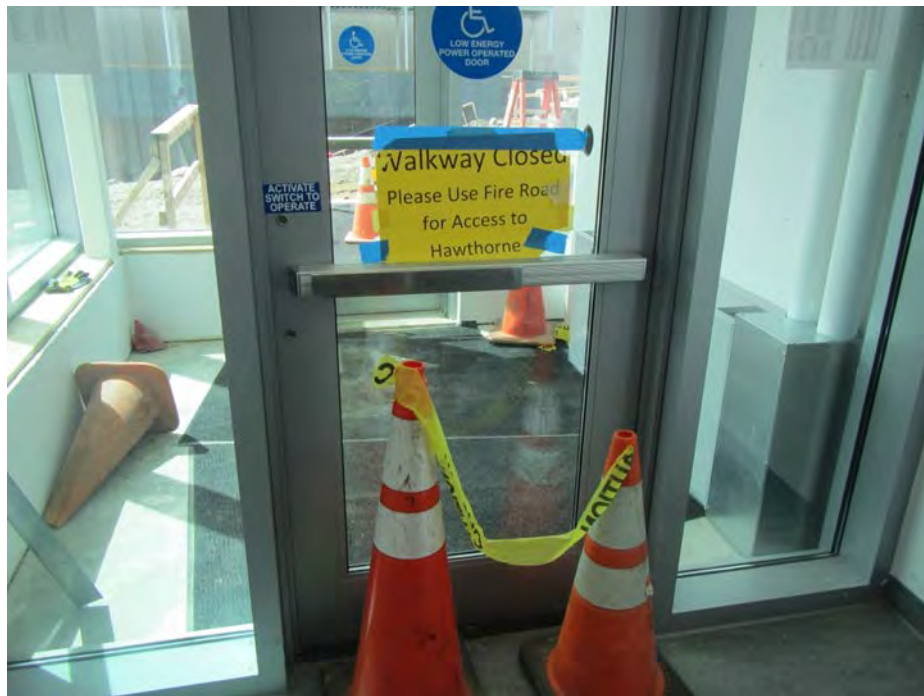
Picture 5

Some doors leading to the construction outside were blocked for access but were noted to have dust/debris tracked in from construction personnel (Pictures 5 to 7). This dust/debris may have irritant effects if allowed to aerosolize within the building. Walk-off mats with an adhesive coating are one method used to prevent the tracking of this debris into occupied areas. Regular wet-wiping of surfaces, HEPA vacuuming, and wet-mopping tile floors will also help to reduce particulate matter in occupied areas.

Door leading to construction outside

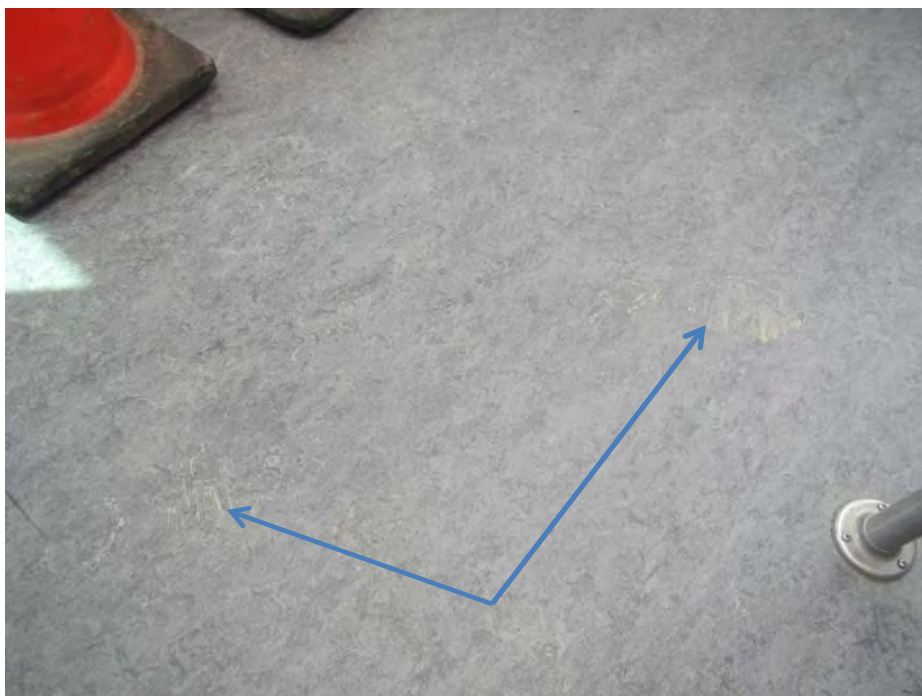
Picture 6

Dust/debris from construction area tracked into hall (no walk off mat inside)

2. Continue to perform regular HEPA vacuuming and wet-wiping of surfaces to reduce the risk of aerosolized dust/debris from construction activities.
3. Educate occupants to refrain from opening windows during the cooling season (while AC is operating) to avoid condensation on porous building materials.

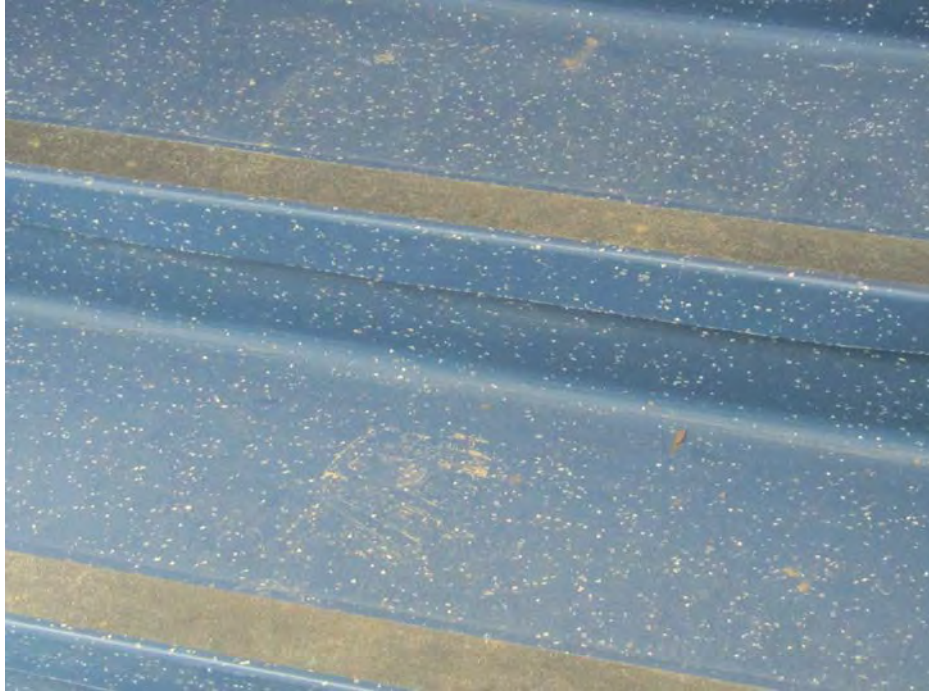
Picture 7

Dust/debris from construction access door leading upstairs
